INFRARED THERMOGRAPHY REPORT

Sample of Infrared

PT. LANCAR MAKMUR SEJAHTERA

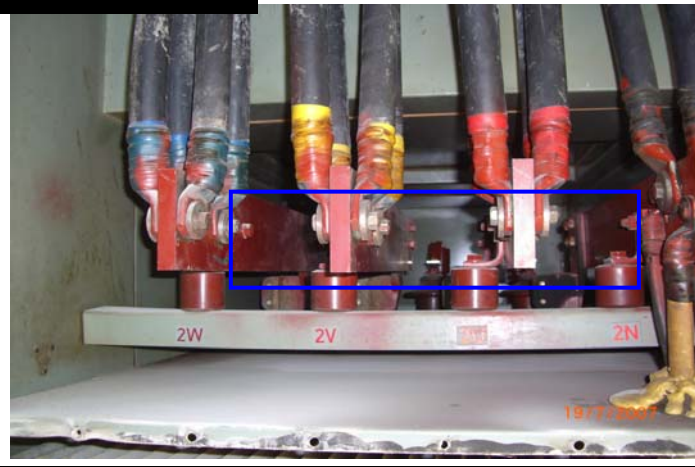
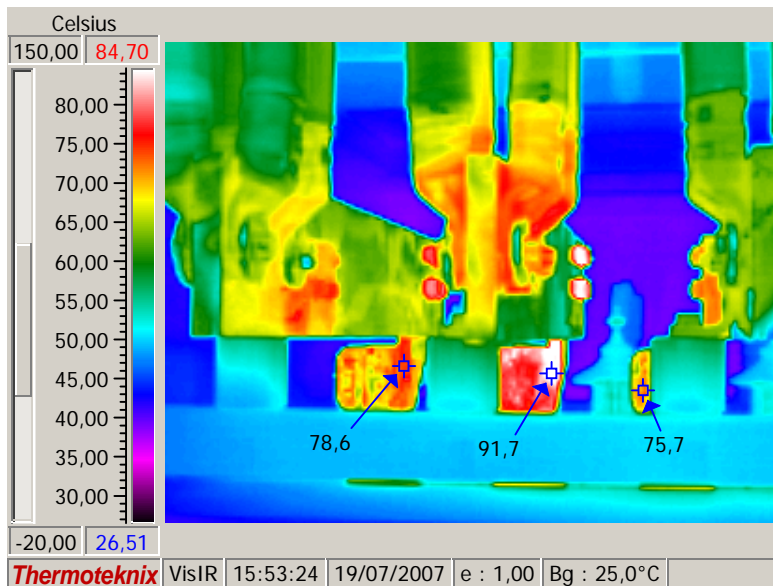
PHOTO NO.	01
DATE	19 JULY 2007
SUPERVISOR	BP. BUDIMAN SIMAMORA
LOCATION	ENERGY HOUSE ROOM
EQUIPMENT	TRAFO 1 PAUWELS 2000 KVA
OBJECT	BUSHING LV PHASE "R, S & T"
MADE BY	PT. LANCAR MAKMUR SEJAHTERA
CLIENT	CONTOH LAPORAN

TEMPERATURE DATA (° C)	
HOT SPOT	91.7 ° C
TEMPERATURE REFERENCE	75.7 ° C
PERMITTED MAX. TEMPERATURE	70 ° C
CLASSIFICATION	D
CLASSIFICATION OF RISE IN TEMPERATURE FROM PERMITTED MAXIMUM TEMPERATURE	
A: ≤ MAX. TEMP.	NORMAL FOR DATA
B: ≥ 1°C - 10°C	NEED ATTENTION
C: ≥ 11°C - 20°C	REPAIR DURING NEXT MAINT. PERIOD
D: ≥ 21°C - 40°C	REPAIR AS SOON AS POSSIBLE
E: ≥ 41°C	REPAIR IMMEDIATELY

Comment / Suggestion
X	Bad Connection	TEMPERATUR KONEKSI BUSHING TINGGI LAKUKAN PENGETESAN DISOLVE GAS ANALISA GUNA MENGETAHUI KANDUNGAN GAS DALAM TRAFO DISEBABKAN KONEKSI INTERNAL TRAFO YANG TIDAK BAIK. KENCANGKAN KONEKSI BUSHING TRAFO TERSEBUT
	Overload	
	Unbalance Loaded	
X	Internal Component / Parts failure	
	Electromagnetic Induction	
	Normal Operating Temperature

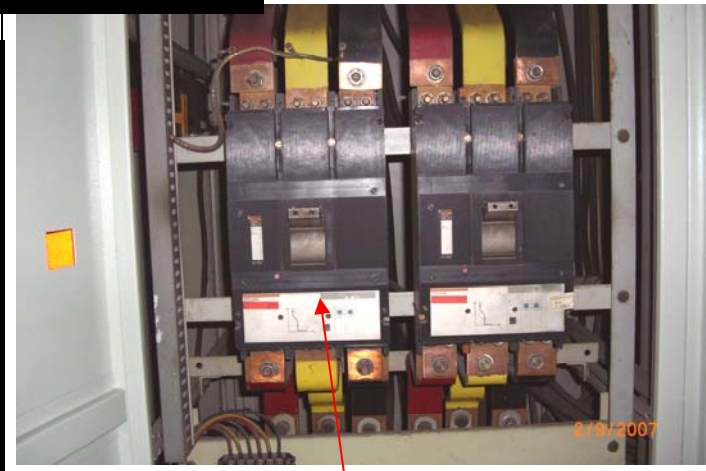
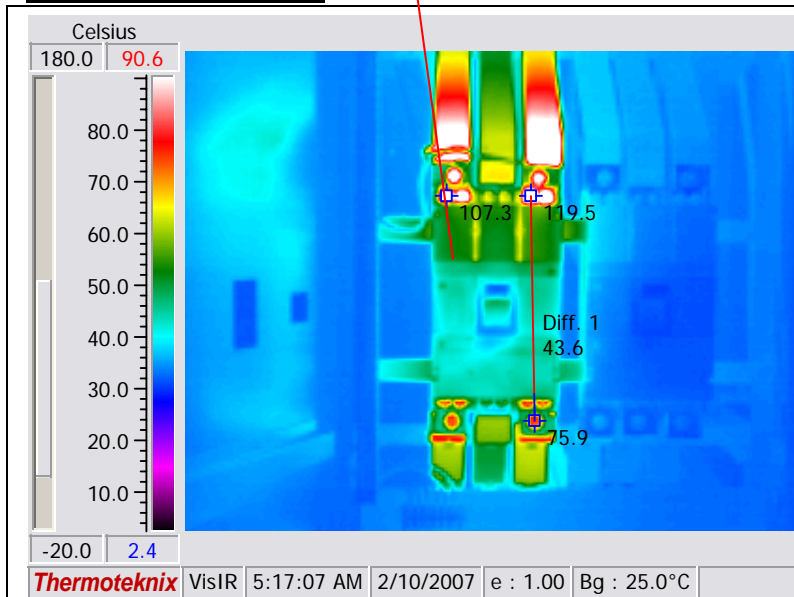
PHOTO NO.	02
DATE	9 FEBRUARI 2007
SUPERVISOR	BP. HAMZAH
LOCATION	CHILLER ROOM
EQUIPMENT	MCC-2 - PP. CHILLER 2
OBJECT	MCCB NO. 3
MADE BY	PT. LANCAR MAKMUR SEJAHTERA
CLIENT	CONTOH LAPORAN

TEMPERATURE DATA (° C)	
HOT SPOT	119.5 ° C
TEMPERATURE REFFERENCE	75.9 ° C
PERMITTED MAX.TEMPERATURE	70 ° C
CLASSIFICATION	E
CLASSIFICATION OF RISE IN TEMPERATURE FROM PERMITTED MAXIMUM TEMPERATURE	
A: ≤ MAX. TEMP.	NORMAL FOR DATA
B: ≥ 1°C - 10°C	NEED ATTENTION
C: ≥ 11°C - 20°C	REPAIR DURING NEXT MAINT. PERIOD
D: ≥ 21°C - 40°C	REPAIR AS SOON AS POSSIBLE
E: ≥ 41°C	REPAIR IMMEDIATELY

Probable Causes		Comment / Suggestion
X	Bad Connection	TERJADI KENAIKAN TEMPERATUR PADA MCCB DISEBABKAN KONTAK POINT MCCB KOTOR LAKUKAN KALIBRASI PADA PERALATAN TSB, JIKA PERLU GANTI DENGAN YANG BARU INSPEKSI ULANG 2 BULAN MENDATANG
	Overload	
	Unbalance Loaded	
X	Internal Component / Parts failure	
	Electromagnetic Induction	
	Normal Operating Temperature

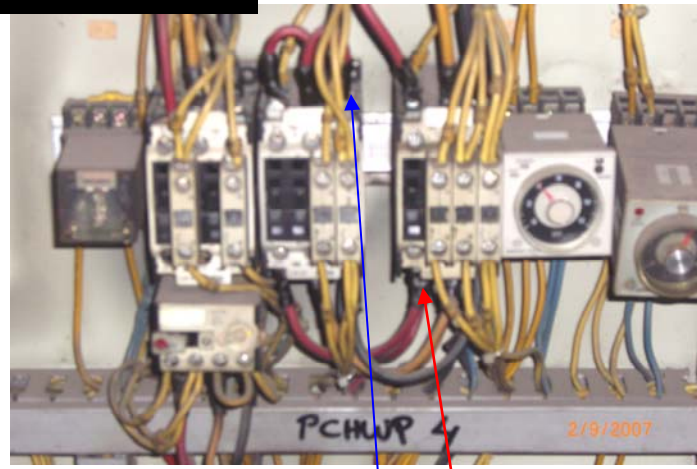
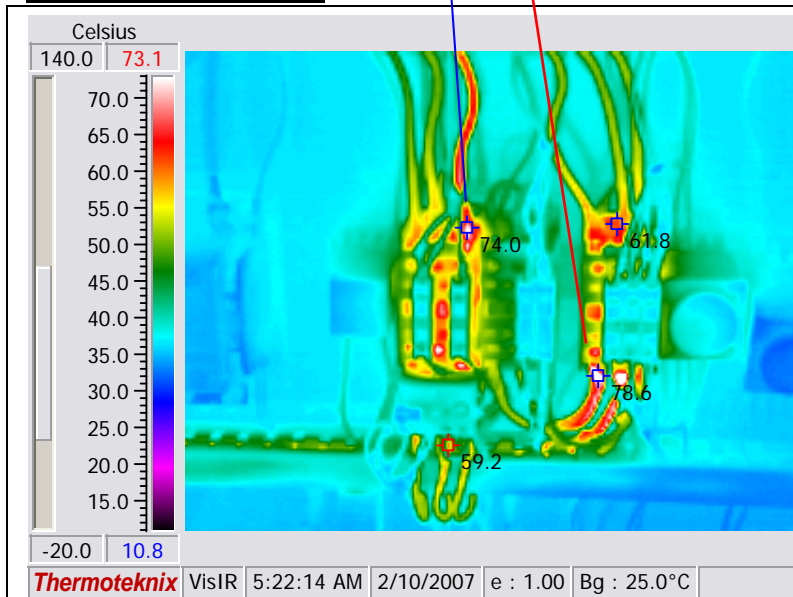
PHOTO NO.	03
DATE	10 FEBRUARI 2007
SUPERVISOR	BP. HAMZAH
LOCATION	CHILLER ROOM
EQUIPMENT	MCC-2 – OUTGOING 2 CT CH 3-4
OBJECT	KONTAKTOR CHWP 3
MADE BY	PT. LANCAR MAKMUR SEJAHTERA
CLIENT	CONTOH LAPORAN

TEMPERATURE DATA (° C)	
HOT SPOT	78.6 ° C
TEMPERATURE REFERENCE	61.8 ° C
PERMITTED MAX. TEMPERATURE	60 ° C
CLASSIFICATION	C
CLASSIFICATION OF RISE IN TEMPERATURE FROM PERMITTED MAXIMUM TEMPERATURE	
A: ≤ MAX. TEMP.	NORMAL FOR DATA
B: ≥ 1°C - 10°C	NEED ATTENTION
C: ≥ 11°C - 20°C	REPAIR DURING NEXT MAINT. PERIOD
D: ≥ 21°C - 40°C	REPAIR AS SOON AS POSSIBLE
E: ≥ 41°C	REPAIR IMMEDIATELY

X	Bad Connection	Comment / Suggestion
	Overload	BEBERAPA KONEKSI KABEL PADA KONTAKTOR TIDAK BAIK GANTI KABEL JUMPER KONTAKTOR DENGAN YANG BARU KENCANGKAN KONEKSI KABEL TSB. INSPEKSI ULANG 2 BULAN MENDATANG
	Unbalance Loaded	
	Internal Component / Parts failure	
	Electromagnetic Induction	
	Normal Operating Temperature

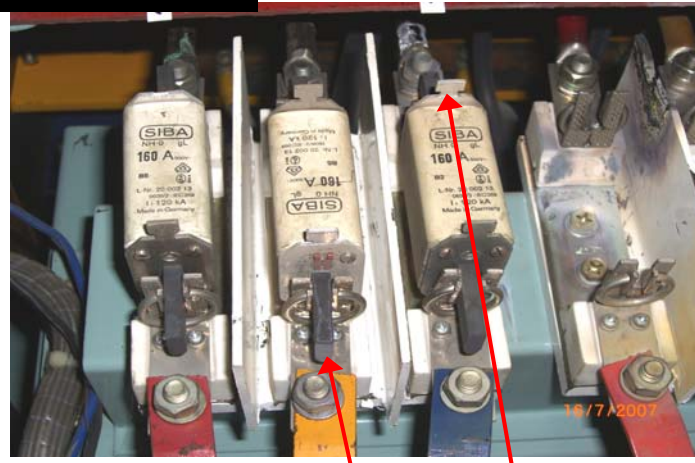
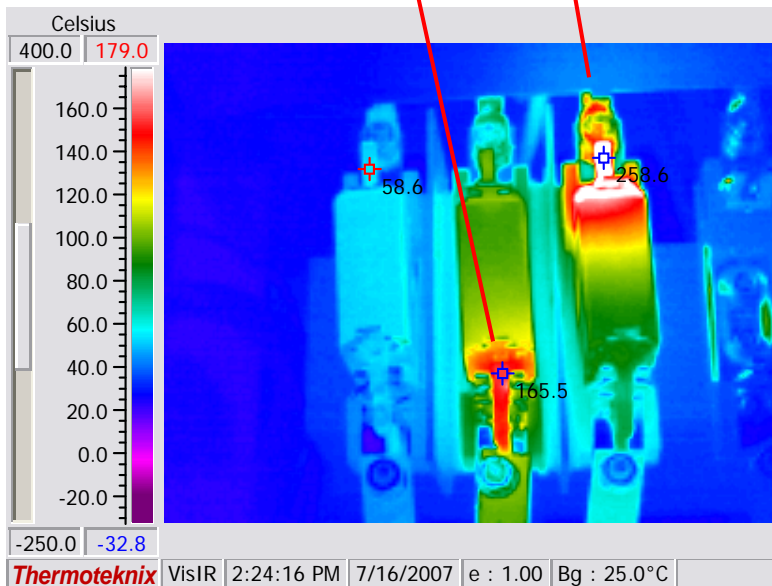
PHOTO NO.	04
DATE	16 JULY 2007
SUPERVISOR	BP. RUSTEN PURBA
LOCATION	RUANG CHILLER
EQUIPMENT	MCC-1 CAPASITOR BANK CELL 1
OBJECT	FUSE STEP 2
MADE BY	PT. LANCAR MAKMUR SEJAHTERA
CLIENT	CONTOH LAPORAN

TEMPERATURE DATA (° C)	
HOT SPOT	258.6 ° C
TEMPERATURE REFFERENCE	58.6 ° C
PERMITTED MAX. TEMPERATURE	70 ° C
CLASSIFICATION	E
CLASSIFICATION OF RISE IN TEMPERATURE FROM PERMITTED MAXIMUM TEMPERATURE	
A: ≤ MAX. TEMP.	NORMAL FOR DATA
B: ≥ 1°C - 10°C	NEED ATTENTION
C: ≥ 11°C - 20°C	REPAIR DURING NEXT MAINT. PERIOD
D: ≥ 21°C - 40°C	REPAIR AS SOON AS POSSIBLE
E: ≥ 41°C	REPAIR IMMEDIATELY

Bad Connection	Comment / Suggestion
X	Overload	PENGAMAN LEBUR FUSE & PENJEPIT FUSE PHASE "S & T" SUDAH TIDAK BAIK GANTI FUSE & PENJEPIT FUSE DENGAN YANG BARU INSPEKSI ULANG 2 BULAN MENDATANG
	Unbalance Loaded	
X	Internal Component / Parts failure	
	Electromagnetic Induction	
	Normal Operating Temperature

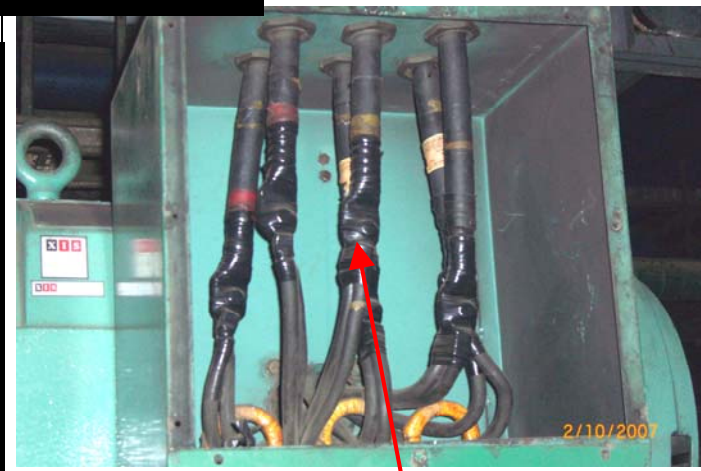
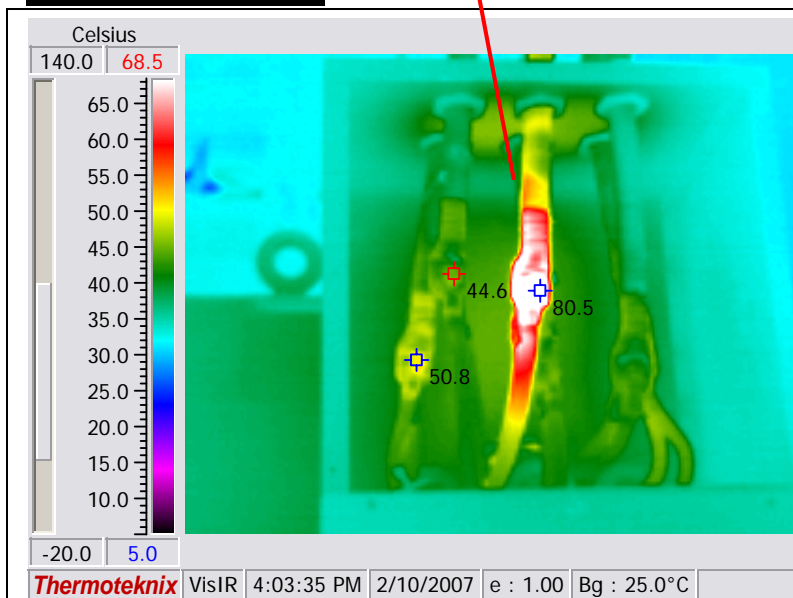
PHOTO NO.	05
DATE	10 FEBRUARI 2007
SUPERVISOR	BP. SISWANTO
LOCATION	RUANG CHILLER
EQUIPMENT	PANEL CHILLER UNIT 2
OBJECT	KABEL
MADE BY	PT. LANCAR MAKMUR SEJAHTERA
CLIENT	CONTOH LAPORAN

TEMPERATURE DATA (° C)	
HOT SPOT	80.5 ° C
TEMPERATURE REFFERENCE	44.6 ° C
PERMITTED MAX.TEMPERATURE	60 ° C
CLASSIFICATION	C
CLASSIFICATION OF RISE IN TEMPERATURE FROM PERMITTED MAXIMUM TEMPERATURE	
A: ≤ MAX. TEMP.	NORMAL FOR DATA
B: ≥ 1°C - 10°C	NEED ATTENTION
C: ≥ 11°C - 20°C	REPAIR DURING NEXT MAINT. PERIOD
D: ≥ 21°C - 40°C	REPAIR AS SOON AS POSSIBLE
E: ≥ 41°C	REPAIR IMMEDIATELY

X	Bad Connection	Comment / Suggestion
	Overload	KONEKSI SAMBUNGAN KABEL PHASE "S" TIDAK BAIK BUKA SAMBUNGAN KABEL, BERSIHKAN DAN KENCANGKAN KONEKSI TERSEBUT, JIKA PERLU GUNAKAN TERMINAL KABEL INSPEKSI ULANG 2 BULAN MENDATANG
	Unbalance Loaded	
	Internal Component / Parts failure	
	Electromagnetic Induction	
	Normal Operating Temperature
